TOWN OF AMENIA

AMENIA WATER DISTRICT #1

INCIDENT REPORT

Water Main Break Friday, April 5, 2024

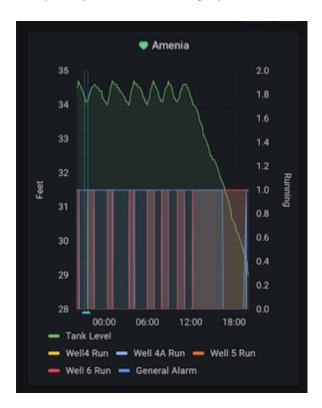
VRI remotely monitors the Water District's wells and water storage tank levels remotely. They reviewed the tank level and found it had decreased a few feet from its normal level. VRI contacted Stanley Whitehead to perform the excavation at the identified water main break location. He was not available Friday evening and said he could arrive on site the following morning. Due to the rate at which the water storage tank was declining, VRI did not feel comfortable waiting until Saturday morning to perform the work and risk draining the tank completely – see tank level graph below.

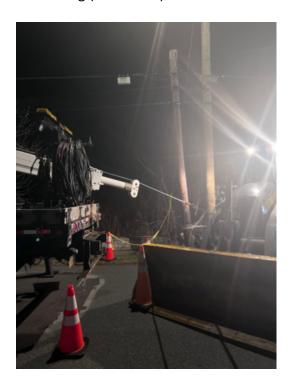
The break was located approximately 10 feet from a telephone pole. VRI felt it was best to contact Metzger construction to have them utilize their hydro-excavator to keep the excavation as minimal and less invasive as possible.

VRI also contacted UDig NY; to alert other utilities for mark-out purposes, and NYSEG to request they hold the telephone pole while the break was repaired. All utilities were clear, and NYSEG arrived with 2 utility trucks to hold/stabilize the pole, so it did not fall or kick out on while excavating (see below).

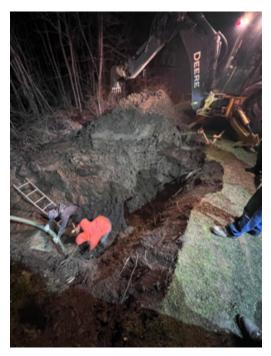
the portion for repair. Those valves did not hold and the pipe was still pressurized at the break. The only way to reduce the flow of water enough to enable repairs was to close the valve leaving the storage tank. The storage tank valve pit was full of water and the electric was not operational. Using a sump pump, VRI cleared the pit of water. A new sump pump will need to be installed in pit and some electrically will need replacing.

Hydrants on either side of Mechanic Street were opened to reduce pressure in the line. Once the water slowed enough so the repair could be made, VRI cut out approximately 4 feet of the ductile iron pipe and replaced it with a plastic section of pipe and 2 hymax's. After the repair was completed, VRI opened 4 hydrants on Mechanic Street, Route 343, and in front of Town Hall to bleed air from and re-pressurize the distribution system. System-wide water was off for approximately 3.5 hours.
