# **ENGINEERING REPORT**

## **Town of Amenia Water District #1: Water System Evaluation**

**DECEMBER 4, 2024**

Public Water Supply (PWS) # NY 1302759

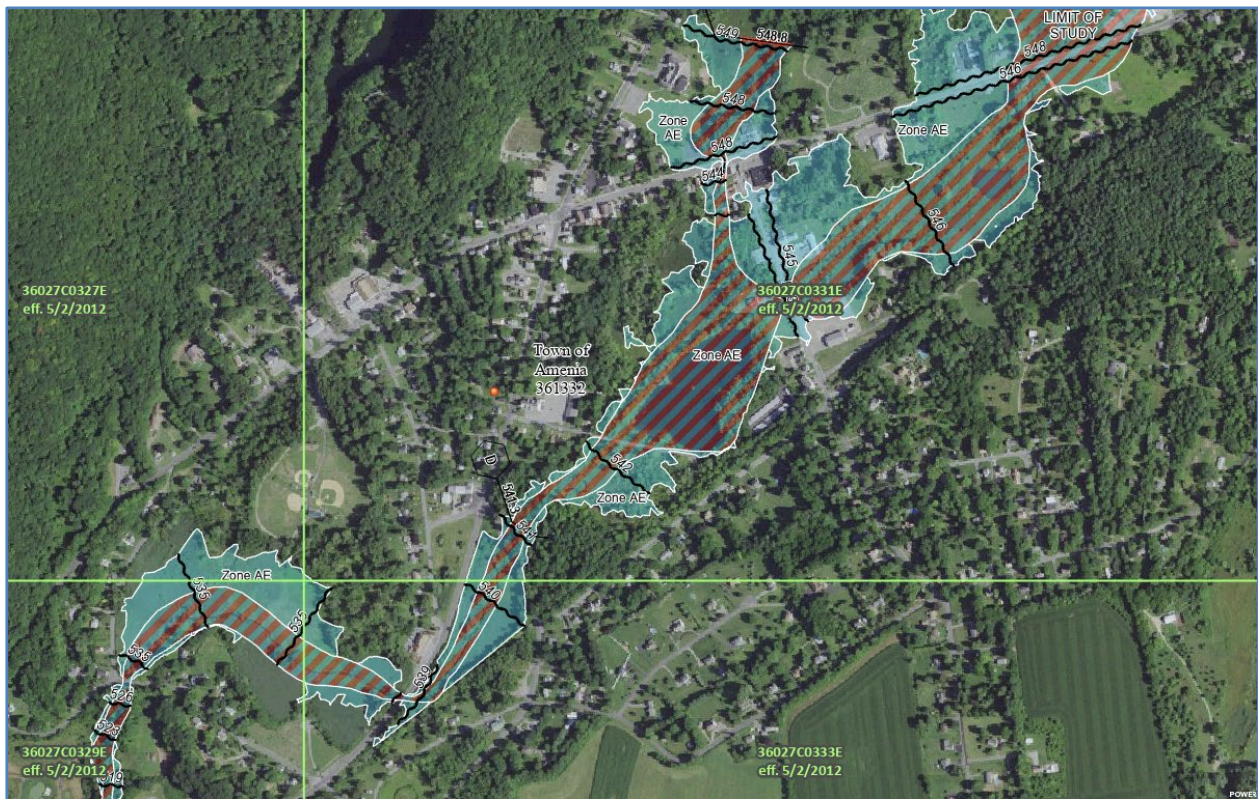
Figure 6. FEMA Flood Map of Amenia Water District #1

Water District #1 traverses four FEMA Floor Insurance Rate Map (FIRM) panels: 36027C0327E, 36027C0331E, 36027C0329E, and 36027C0333E. According to [FEMA](#), a significant portion of the AOI is mapped within the Special Flood Hazard Zone (Zone AE). The Zone AE regions are primarily located along the Wassaic Creek and its tributaries. See **Figure 6**.

The Town of Amenia will ensure that all vital equipment is elevated above the Base Flood Elevation (BFE) in these areas as part of the proposed project.

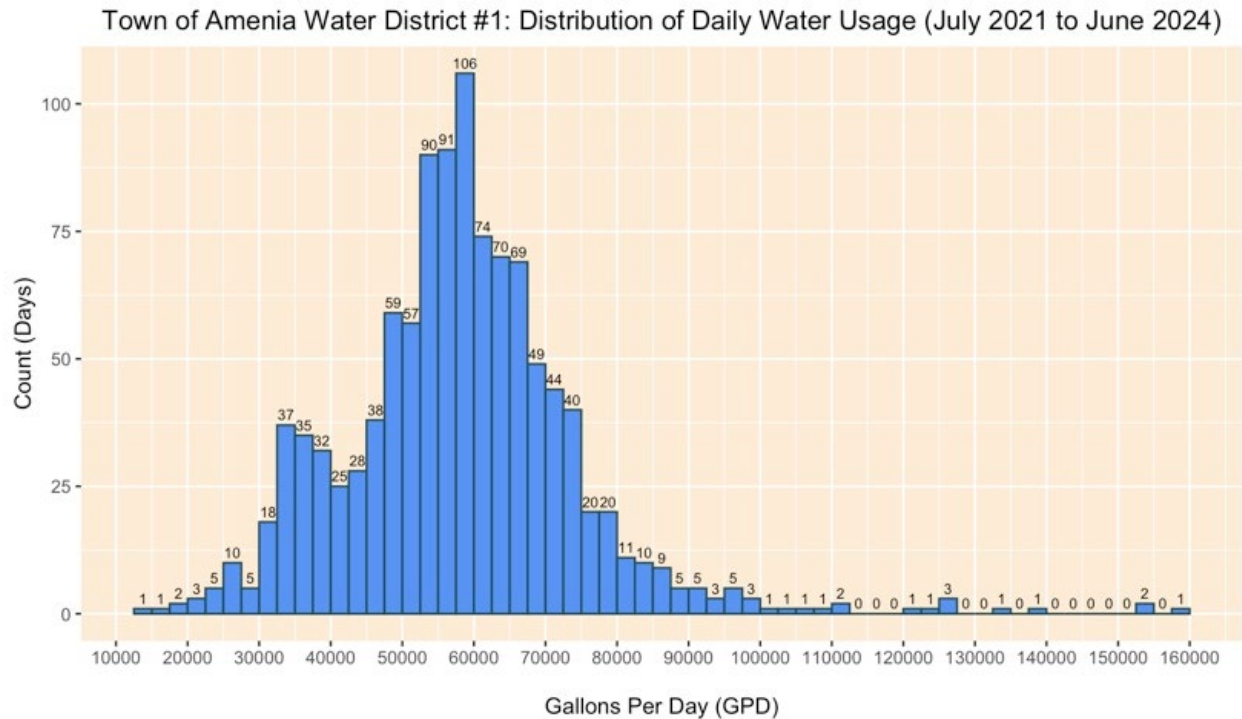
Figure 7 below illustrates the distribution of daily water usage in the Town of Amenia Water District #1 over a three-year period, from July 2021 to June 2024. The x-axis represents the daily water usage in gallons per day (GPD), with a bin width of 2,500 gallons, while the y-axis indicates the number of days with that fall within a specific usage range. During this

Figure 7. Histogram showing the distribution of daily water usage in the Town of Amenia Water District #1 from July 2021 to June 2024.

period, the water system's daily production has ranged from 14,300 to 160,000 gallons, with the central 98% of this range falling between approximately 25,000 and 111,000 gallons per day. The histogram reveals a distribution that is roughly symmetric around the central range of usage values, with the highest frequency observed in the bins around 60,000 to 62,500 gallons per day. The counts increase towards this central peak and then decrease symmetrically. Notable deviations from symmetry include a few large values that create spikes in the higher bins. Despite these outliers, the overall distribution exhibits a balanced shape, suggesting that water usage values are generally centered around the middle of the observed range, with extreme values being less frequent.

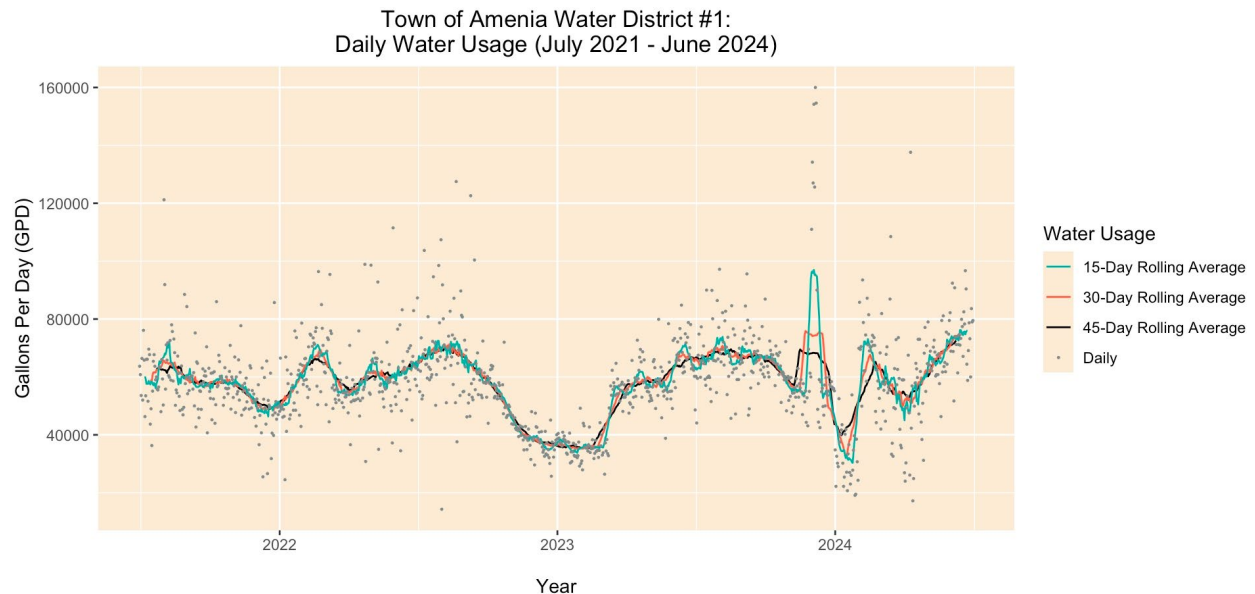
**Figure 8** below shows the actual daily water usage in grey and the 15-day, 30-day, and 45-day rolling averages of daily water usage in Water District #1 over a three-year period,

Figure 8. Daily water usage and 15-day, 30-day, and 45-day rolling averages of daily water usage in the Town of Amenia Water District #1 from July 2021 to June 2024.

from July 2021 to June 2024. The 15-day, 30-day, and 45-day rolling averages are fairly close together, indicating a consistent trend without significant short-term fluctuations. However, while the overall trend is stable, there are occasional spikes in daily usage. The plot also reveals some minor seasonal variations, with peak usage occurring during the summer months and lower usage during the winter. But the overall trend remains relatively stable, suggesting that factors like weather or climate are not causing major disruptions.

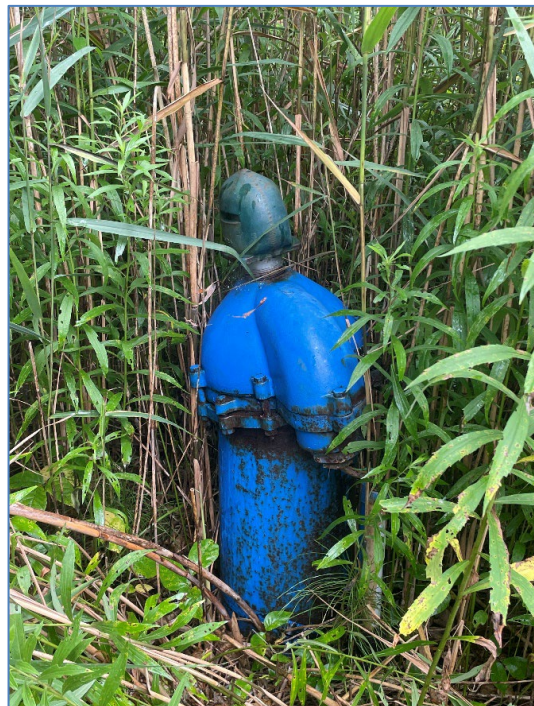
Figure 9. Photo of Well 4A

Well 4A is located immediately southeast of Well 4 at the Lavelle Road site. It was constructed in 2006 to supplement the existing public water supply. This well features 8-inch steel casing to 168 feet and is finished as an open hole at a depth of 200 feet in carbonate bedrock. Its maximum pumping rate is approximately 44 GPM, according to the 2020 water withdrawal form (see **Appendix E**), and it is permitted for 64 GPM (see **Appendix F**). Water from Well 4A is treated with chlorine before entering the distribution system. Well 4A has the following deficiencies:

- It is GWUDI due to its proximity to a lake and wetland.
- The previous operator reported to the DCDOH that it produces fine silt, which clogs equipment and increases maintenance demands.

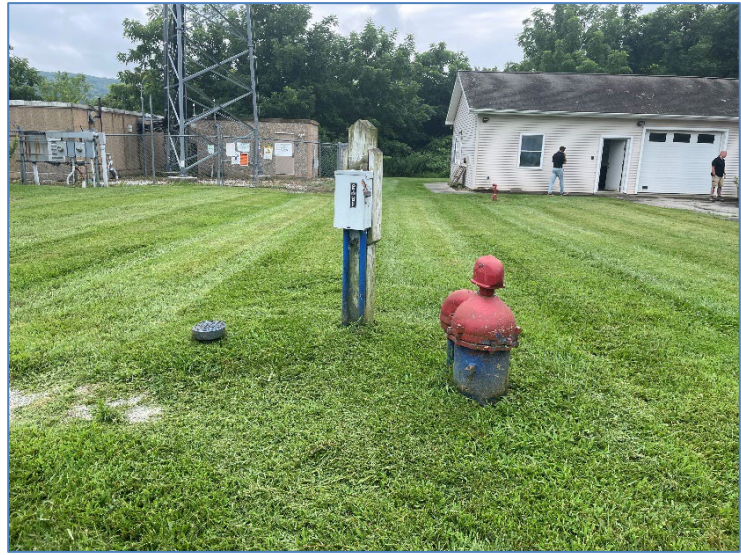
Figure 10. Photo of Well 5

Well 5 is located at the Washington Court site and was deepened in June 2023 from 325 feet to 845 feet to improve its yield and reliability. It features an 8-inch casing, with the pump installed at 800 feet. After these upgrades, the well demonstrated a source capacity of 20 GPM, and it is permitted for 19 GPM (see **Appendix F**). However, it is currently out of service due to water quality issues.

Well 5 has the following deficiencies:

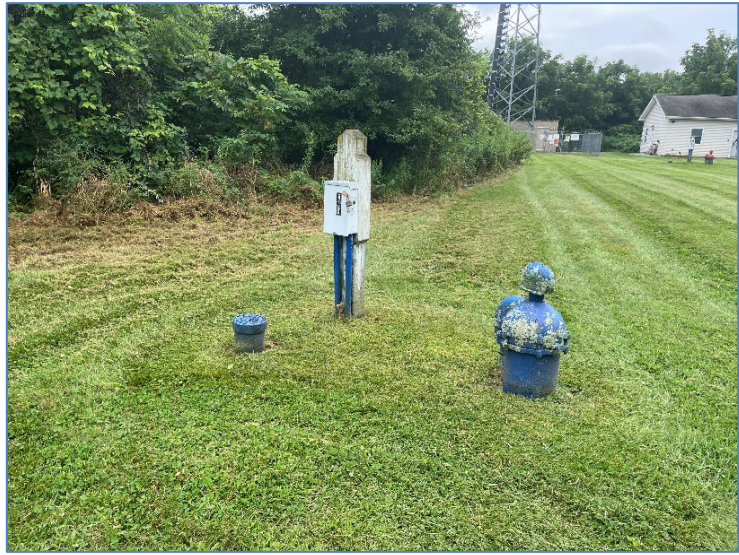
Figure 11. Photo of Well 6

Well 6 is also located at the Washington Court site. It is a bedrock well with an 8-inch casing and a depth of 500 feet. The source capacity is approximately 32 GPM, according to the 2020 water withdrawal form (see Appendix E), and it is permitted for 30 GPM (see **Appendix F**). Water is treated with chlorine at the Washington Court Pump House before being distributed.

Currently, Well 6 has no reported deficiencies and remains fully operational.

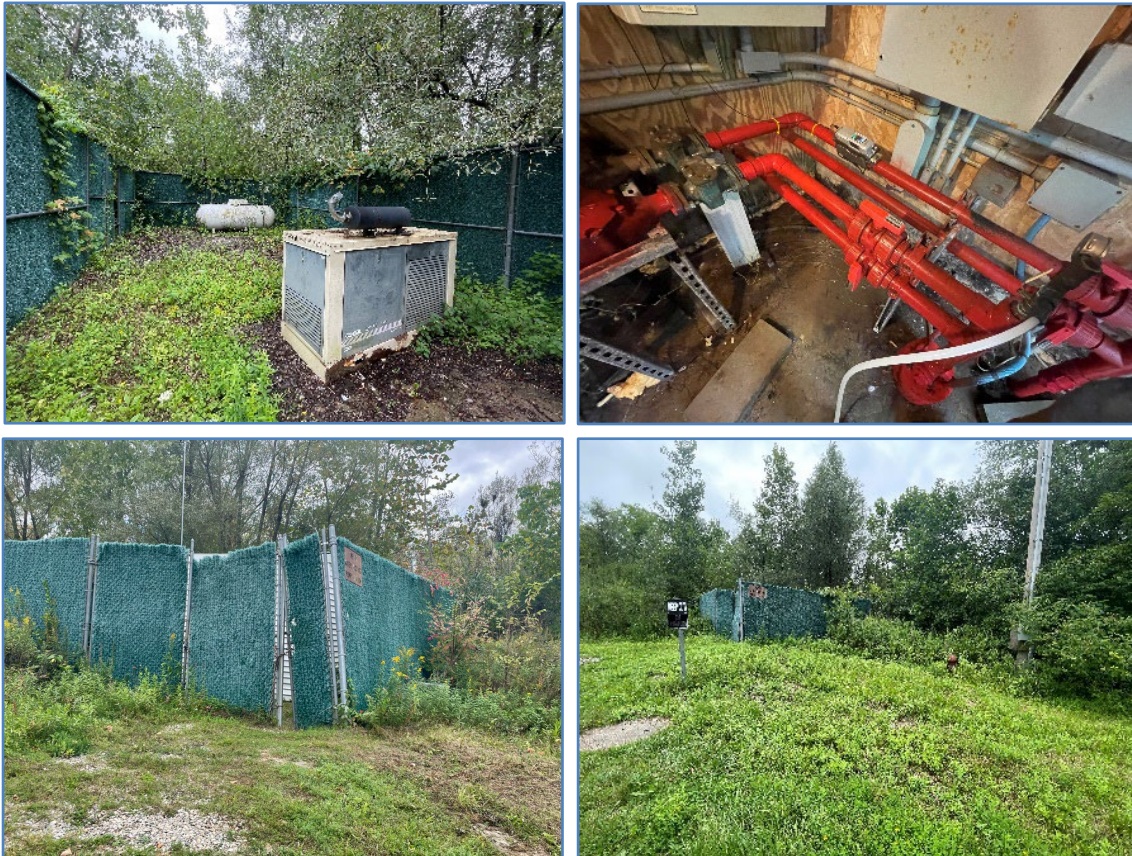
Figure 12. Lavelle Road Pump House and Fence Photos

The Lavelle Road Pump House is located at the end of Lavelle Road in the southern portion of the Water District. It was constructed in the early 2000's. The parcel is owned and operated by the Town of Amenia. This pump house is located just outside of FEMA 1% chance annual flood area and NWI Wetlands but is within a NYSDEC Wetland 500ft

Checkzone. Well 4 is within the pump house and Well 4A is located just southeast of the pump house. From the pump house, treated water from both wells is sent throughout the distribution system via Lavelle Road to both Railroad Avenue and South Street/NYS Route 22. The site is enclosed with a fence and locking gate.

The pump house contains primary electrical circuits, pump motor starters, system controls and a chlorination system as well as a storage tank with sodium hypochlorite solution. The pump house is generally in working order, although, the conditions of the equipment, electrical components and the structure itself are deteriorating due to age.

The structure itself is an 8-foot by 10-foot wooden building with asphalt shingles on top of a slab on grade (no foundation).

The site contains a 20kW Kohler emergency generator and 500-gallon aboveground propane storage tank to supply the generator with fuel. The fuel line travels below grade from the tank to the generator. The concrete pad holding the generator is cracked.

The structure has reached the end of its useful life and is in need of total replacement. The following are noted deficiencies associated with the Lavelle Road Pump House:

- The overall condition of the site is fair and it is clear that regular maintenance is required to keep it from totally deteriorating.

- The structure is located within a wet and damp area. The interior conditions of the pump house indicate water damage moisture saturation and mold growth. This puts the operators at risk of exposure to toxins.

- There is no ventilation or dehumidification installed at the pump house.
- There is evidence of vermin and insect infestation.
- Well 4 is located inside the pump house. Maintenance and repair become difficult without interrupting other vital functions.

- According to Operators, the water from the well occasionally flows to the top of the well without the need for pumping due to existing pressure (artesian). This causes the well to overflow inside the building.

- There is evidence of corrosion on the internal and external equipment. The chlorination system is housed with the water and electrical components which creates a highly corrosive environment for all components inside. This puts the operators at risk of electrocution and exposure to toxins.

- It is difficult for the operators to create an unobstructed working area within the structure which can lead to hazardous or unsafe working conditions. Space is limited with the small footprint of the structure.

- There is restricted access to electrical components and they are not properly protected from water and moisture damage.
- The concrete slab holding the pump house is cracked and located at grade, instead of above grade like would typically be found with these structures.

- The ground is covered in pea gravel and not graded to drain away from the infrastructure. Soil conditions seem generally unsuitable for stormwater infiltration.

- The concrete pad holding the generator is cracked.
- There is minimal lighting at the site.
- The security fence and gate are aged and distressed.
- Site access is provided through a gravel/dirt drive which is uneven due to age and use by maintenance vehicle access.

- Repair and upgrade the Lavelle Road water treatment plant building and fence;
- Evaluate well 4 and well 4A for potential groundwater under the direct influence of surface water;
- Develop a plan to improve the pressure and flow conditions in the distribution system;
- Calculate chlorine contact time; and
- Recoat the water storage tank

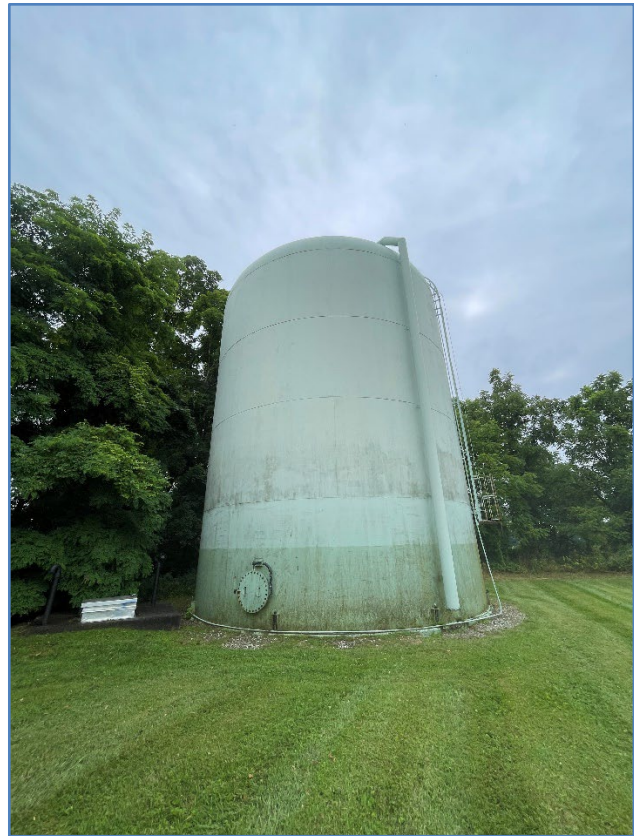
Figure 13. Photo of 200,000-Gallon Water Storage Tank

**Water Tank:** water is stored in a 200,000-gallon, 40-foot-high, 29.5-foot-diameter storage tank/standpipe (see **Figure 13**) located at the Washington Court treatment facility site. The tank was built in 1975. A radio telemetry antenna is located on the side of the Lavelle Road Pump House, which connects the well controls to the remote system storage tank. The storage tank water level regulates the operation of the wells and controls chlorination. The tank is located at approximately 760-feet. The tank is equipped with cathodic protection. It was last inspected in September 2023 and was found to have the following deficiencies:

The tank is experiencing significant deterioration due to age (built in 1975). On the interior surfaces, heavy staining and biofilm buildup are present, and the protective coating is

deteriorating. Due to the age of the tank, the deteriorating coating could be lead based paint.

The tank is experiencing significant deterioration due to age (built in 1975). The exterior surfaces show mildew growth and a thinning protective coating. The overflow screen exhibits corrosion, compromising its functionality. On the interior surfaces, heavy staining and biofilm buildup are present, and the protective coating is deteriorating. There is noticeable corrosion on some of the interior welds, and exposed steel is visible on the floor.

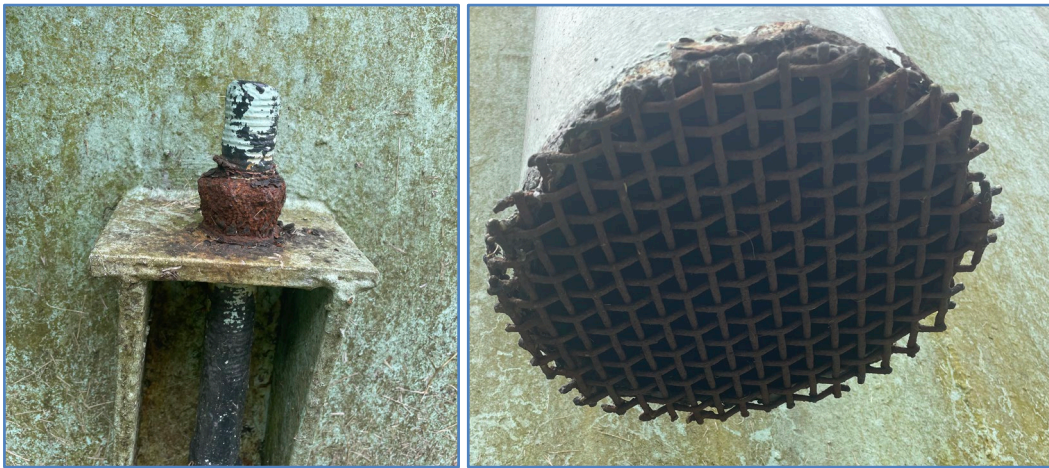
Figure 15. Corrosion on bolt (left) and overfill screen (right).

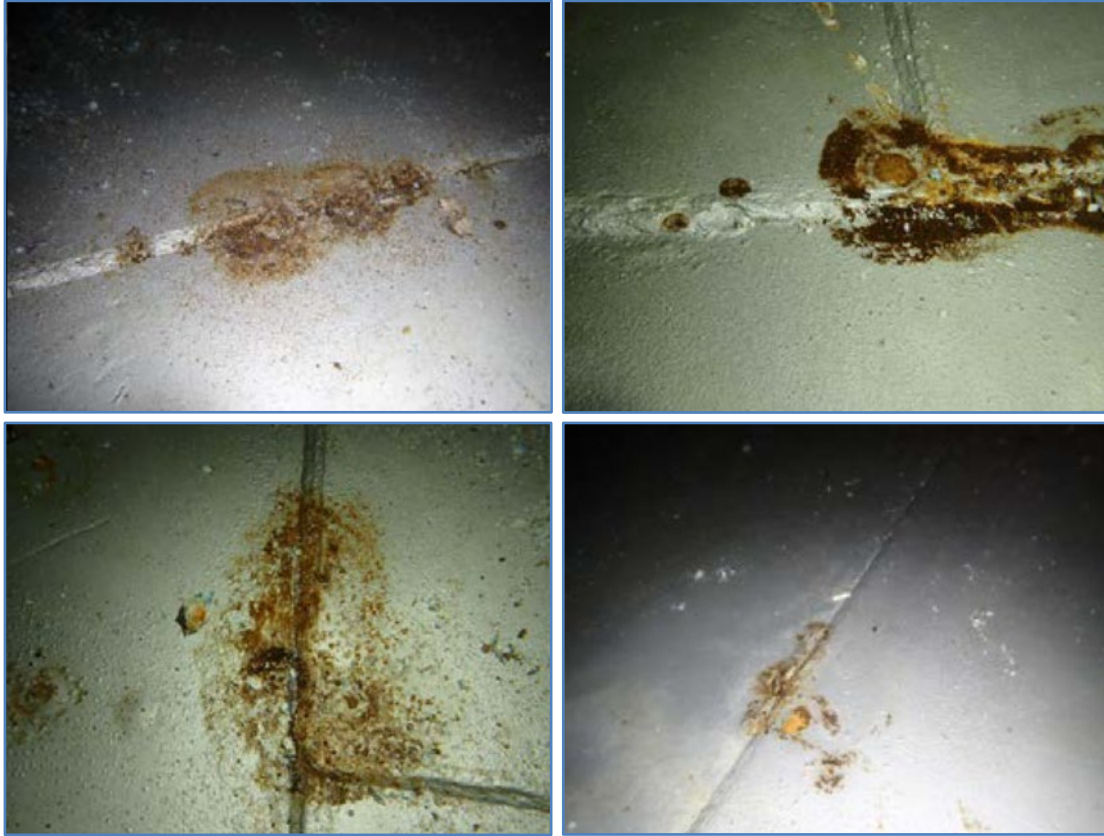
*Figure 16. Corrosion on the internal welds of the water tank.*

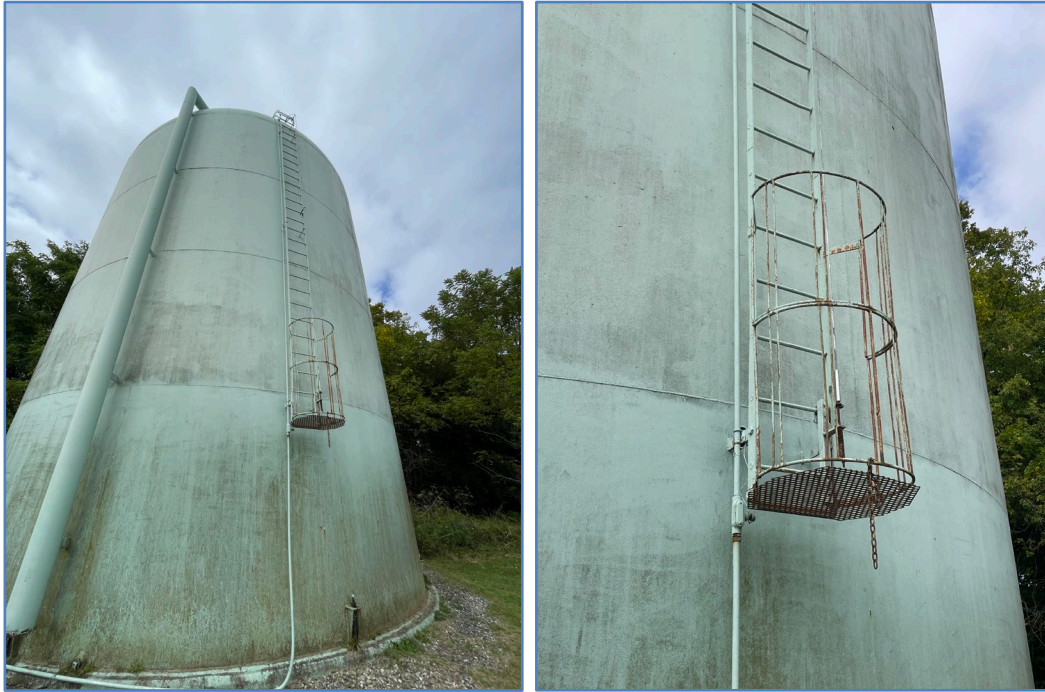
Figure 17. Ladder and ladder cage for water tank.

Additionally, the access ladder on the water tank does not meet current safety standards. According to 29 CFR 1926.1053(a)(20), cages for fixed ladders must extend at least 42 inches above the point of access at the top of the ladder; however, the top of the cage for the fixed ladder on the water tank is substantially below the top of the ladder. See **Figure 17** below. The cage and ladder also exhibit significant corrosion.

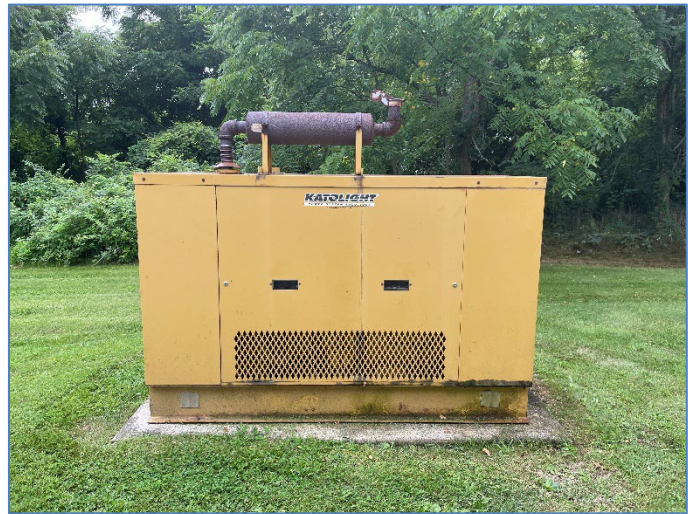
Figure 15. Photo of Water Tank Generator

The water tank site is equipped with a 25-kW, Katolight continuous standby emergency generator.
