TOWN OF AMENIA

AMENIA WATER DISTRICT #1

INCIDENT REPORT

Water Main Break Friday, April 5, 2024

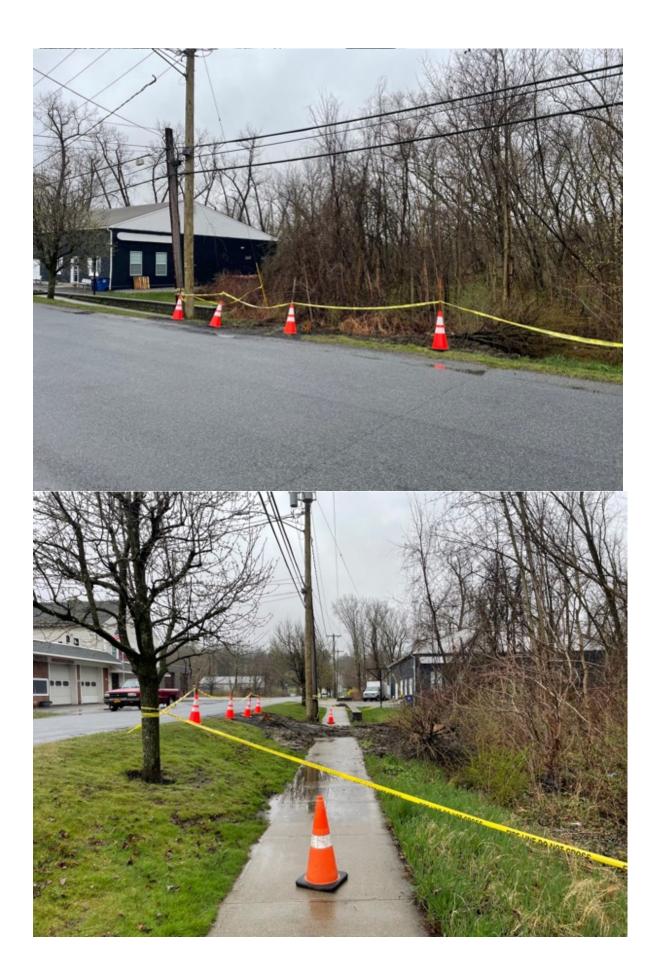
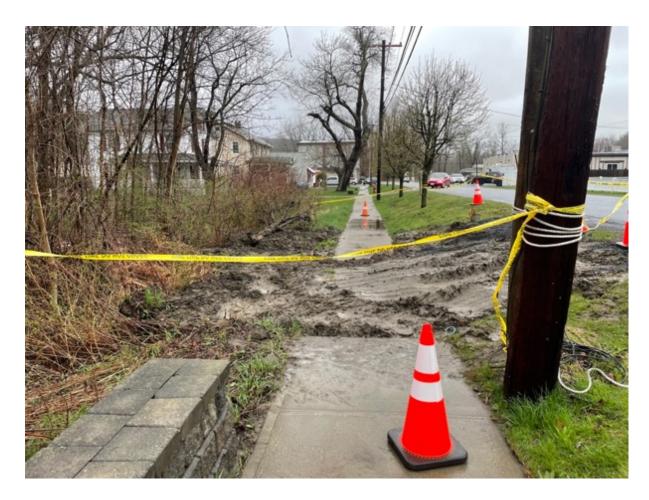
Hydrants on either side of Mechanic Street were opened to reduce pressure in the line. Once the water slowed enough so the repair could be made, VRI cut out approximately 4 feet of the ductile iron pipe and replaced it with a plastic section of pipe and 2 hymax's. After the repair was completed, VRI opened 4 hydrants on Mechanic Street, Route 343, and in front of Town Hall to bleed air from and re-pressurize the distribution system. System-wide water was off for approximately 3.5 hours.
